CONTRACT NUMBER: FA8532-17-C-0008 (CDRL A002)

Evaluation of the Aircraft Ground Equipment (AGE) at Pacific Air Force (PACAF) Locations

Prepared by:
Battelle
505 King Avenue
Columbus, Ohio 43201

Date: 16 January 2018

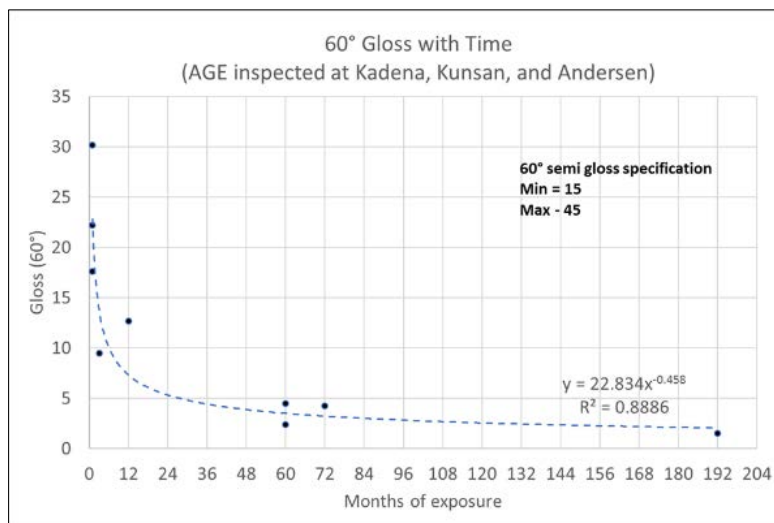
Figure ES- 1. Overview of UV Degradation

Coatings Degradation from Exposure to UV light. Color, gloss, and coatings thickness measurements were taken from the AGE inspected at the three PACAF locations. Results as seen in Figure ES- 1 show significant loss of gloss across the

inspected AGE as quickly as 3 months after being painted. Gloss readings on the MIL-PRF-85285 coating were below the minimum gloss specification of 15 units for semi-gloss in the 60° angle of incidence. Readings for color showed significant change over time from UV exposure. The two parameters indicate high levels of UV degradation of the polyurethane backbone, which in turn reduces the binding between the PU and the pigments. This can cause chalking and roughening of the coating surface which reduces the gloss of the coating. The inspection of AGE at each PACAF locations and the respective readings to determine level of coatings degradation from exposure to UV and, the general modes of corrosion are discussed in details in section 3.0 and evaluation of the PACAF AGE results are discussed in sections 4.1 - 4.3 of this report.

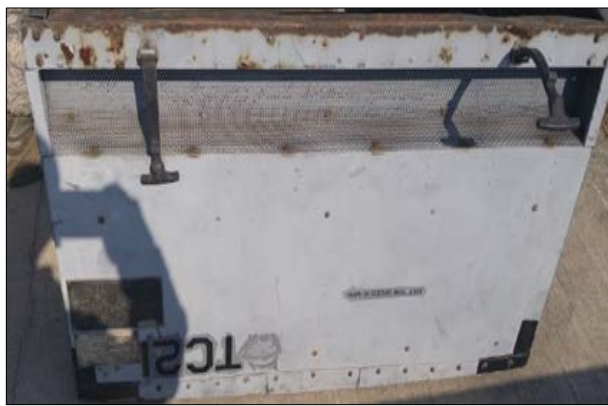
Figure 14 UV degradation over time of AGE coatings at the three PACAF Locations

Figure 14 presents the trend observed on the inspected AGE in gloss reduction through pictures of the AGE at the three PACAF locations.

TC21 Kunsan 192 months Gloss = 1.53

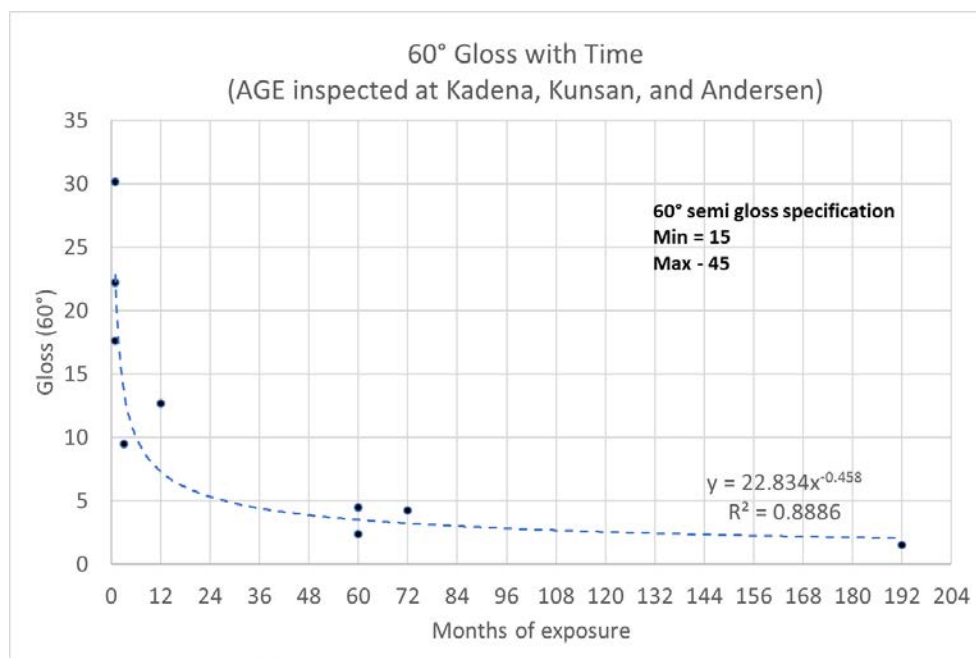
**Figure 15. Plot of 60° gloss readings vs. time**

Assets in which the maturity of the coating could be verified through records were plotted for the 60° gloss readings versus time. This plot included three assets from each of the three PACAF locations. In Figure 16 below we see a dramatic drop in gloss, falling below the minimum specification as soon as three months.

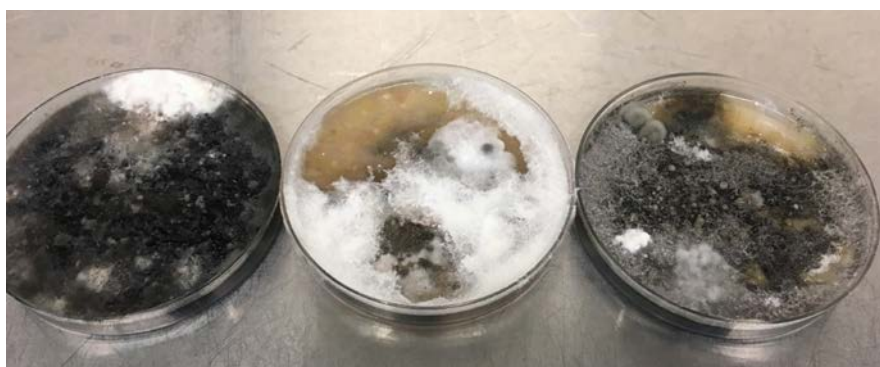
**Figure 23. J-AA05_C PDA plates**

Table 9 describes the fungal morphologies observed on the plates. No isolations were performed on PDA since sequencing was performed also (Section 4.4.1). See Figure 23 for an example of fungal growth observed. Fungal growth was especially prevalent on sample J-AA05_C, the sample from Kadena AB that was a piece of chipped corroded coating (Figure 24) and was presented in Figure 17 under section 4.3.
